CALIFORNIA DIVISION OF MINES AND GEOLOGY

Fault Evaluation Report FER-33

March 28, 1977

1. Name of fault: Montecito fault.
2. Location of fault: Santa Barbara and Carpinteria quadrangles, City of Montecito, Santa Barbara County, California (see figure 1).

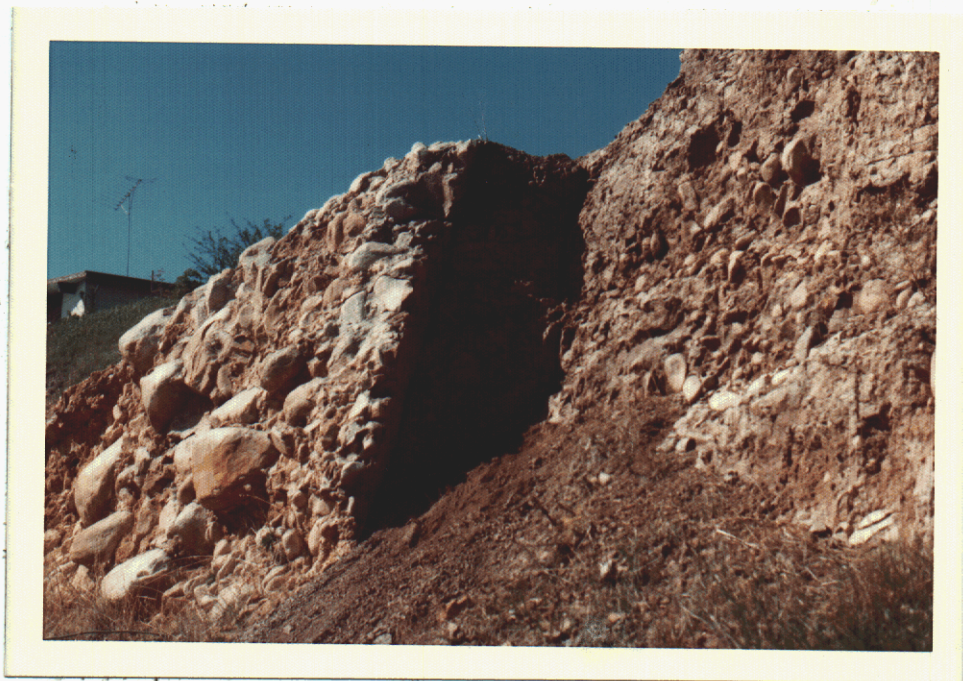
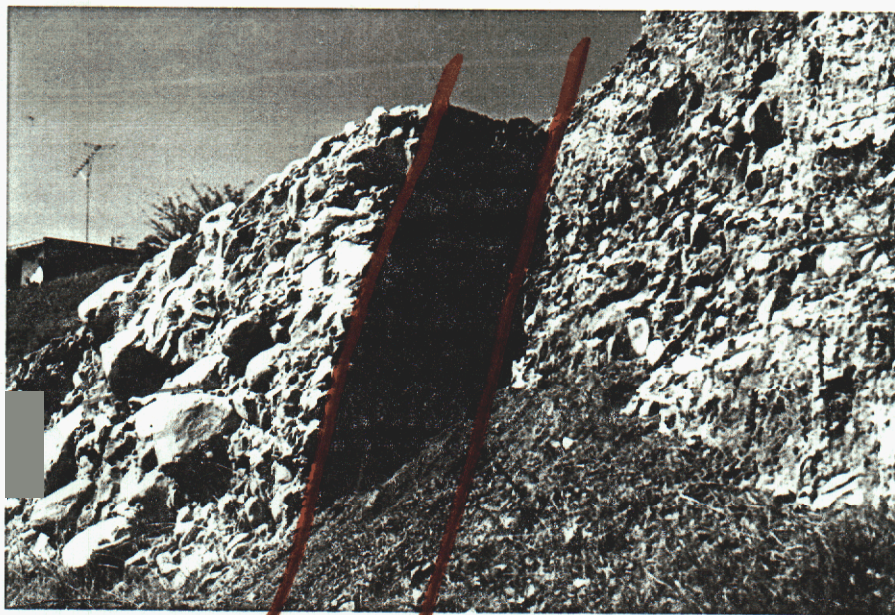
Fig. 4.

- 1) A ^{road} cut on the north side of Chase Street in the City of Montecito revealed the only exposure of the Montecito fault I could find. Here, a bouldery fan[^]glomerate deposit (referred to as terrace deposits by Geotechnical Consultants) is cut by at least two faults, which essentially define one narrow fault zone (see figure 4 with photo). These faults dip steeply to the south and strike N 30° W. The location and attitude of these faults match that shown by Geotechnical Consultants as the Montecito fault. No evidence of rupture in the modern erosional surface was seen.

View looking west at cut exposing faulted
fanglomerates (Geo-tech refers to them as terrace deposits)

Fault - N 80° W
80° southerly dip
